Thilawa Special Economic
Zone (Zone A) Development

Environmental Monitoring Report (Operation Phase)

Myanmar Japan Thilawa
Development Limited.

October 2018

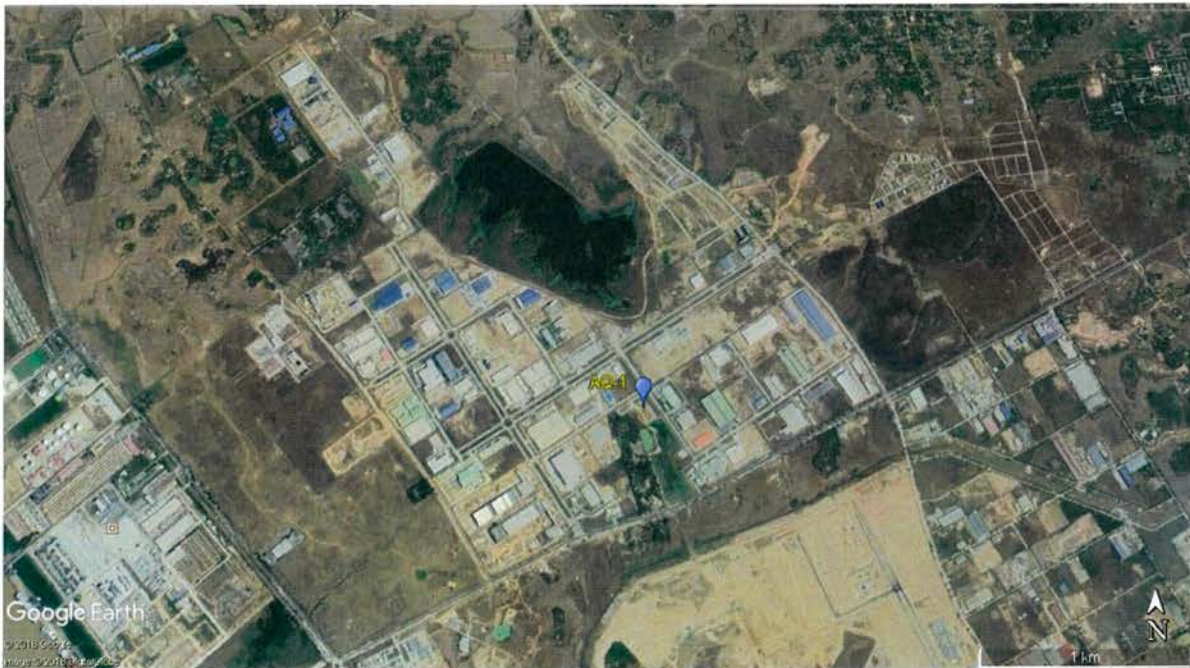
Ni Ni Aye Lwin
Assistant supervisor

The air quality measurement equipment, "Haz-Scanner Environmental Perimeter Air Station (EPAS)" was set up inside the centralized Sewage Treatment Plant (STP) compound which is southeast of the Thilawa SEZ Zone A, N: 16°40'28.38", E: 96°16'34.71", surrounded by the factories of Thilawa SEZ Zone A, north of Dagon Thilawa road and northeast of Moegyoe Swan monastery respectively. Possible emission sources are dust emissions from construction activities and exhaust gas emissions from surrounded factories. The location of air quality monitoring is shown in the Figure 2.2-1.

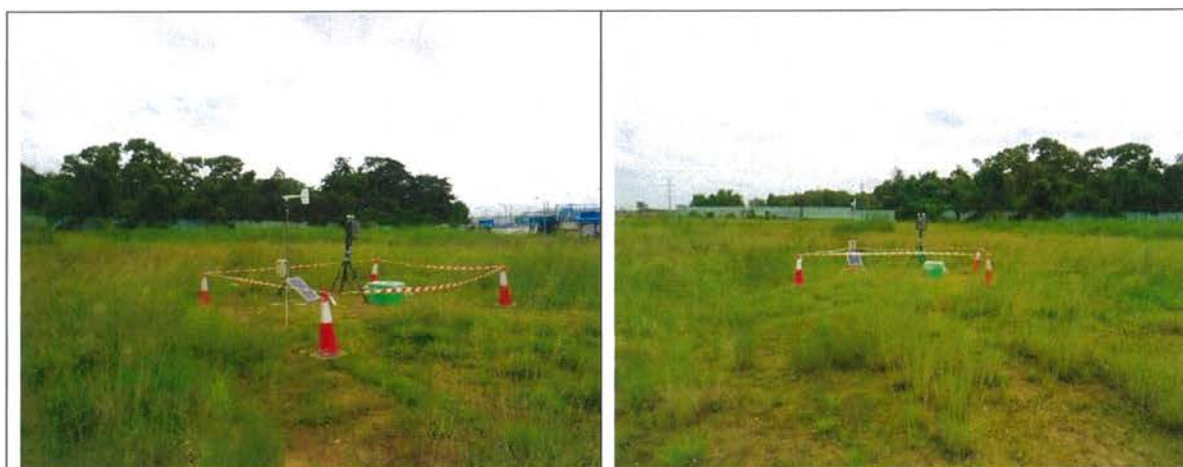
Figure 2.4-1 Status of Air Quality Monitoring Point

Monitoring of CO, NO₂, TSP, PM₁₀, and SO₂ were conducted by referring to the recommendation of the United States Environmental Protection Agency (U.S. EPA). The Haz-Scanner EPAS was used to collect ambient air pollutants. The EPAS measures automatically every one minute and directly read and recorded onsite for CO, NO₂, TSP, PM₁₀, and SO₂. Due to the limitation of the analytical equipment in Myanmar, TSP results was calculated as predicted value which is based on the results of PM₁₀. Therefore, the result of TSP was evaluated using the estimated TSP concentration values. The state of air quality monitoring is shown in Figure 2.4-1.

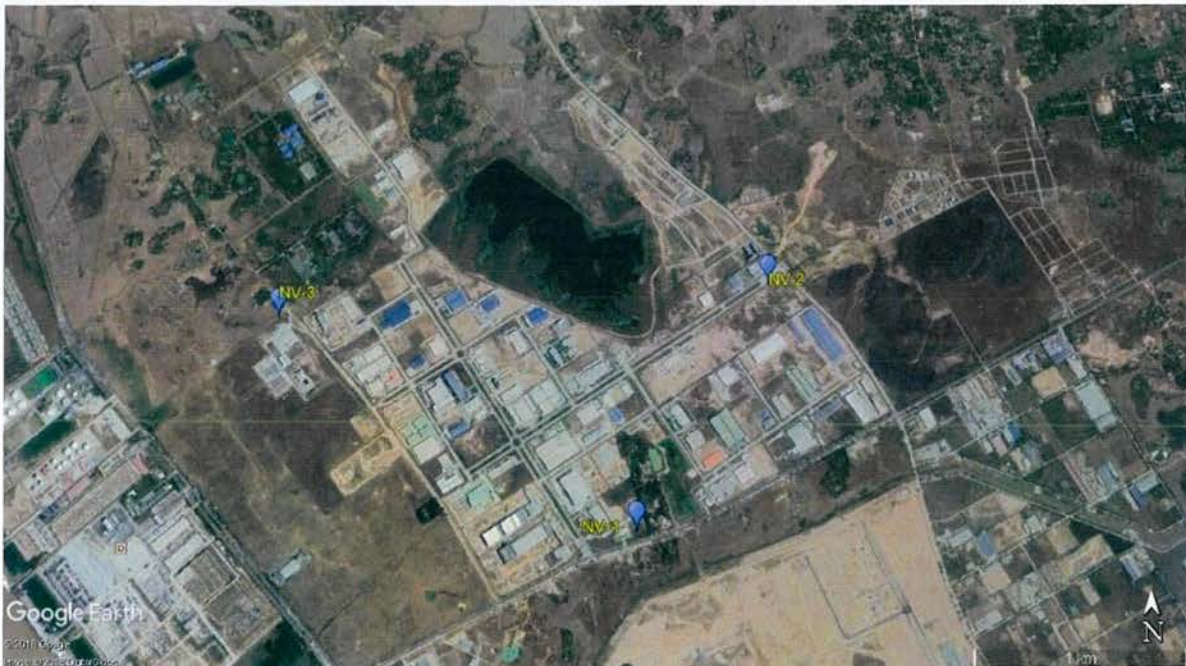
Figure 2.2-1 Location of Noise and Vibration Level Monitoring Points

Sampling Point	Coordinates	Description of Sampling Point
NV-1	N: 16°40'11.50", E: 96°16'32.00"	In front of administrative building, Thilawa SEZ Zone A
NV-2	N: 16°40'52.50", E: 96°16'55.50"	At the east of the Thilawa SEZ Zone A
NV-3	N: 16°40'46.20", E: 96°15'30.10"	At the west of the Thilawa SEZ Zone A, where is the nearest to the residential houses of Alwan sok village.

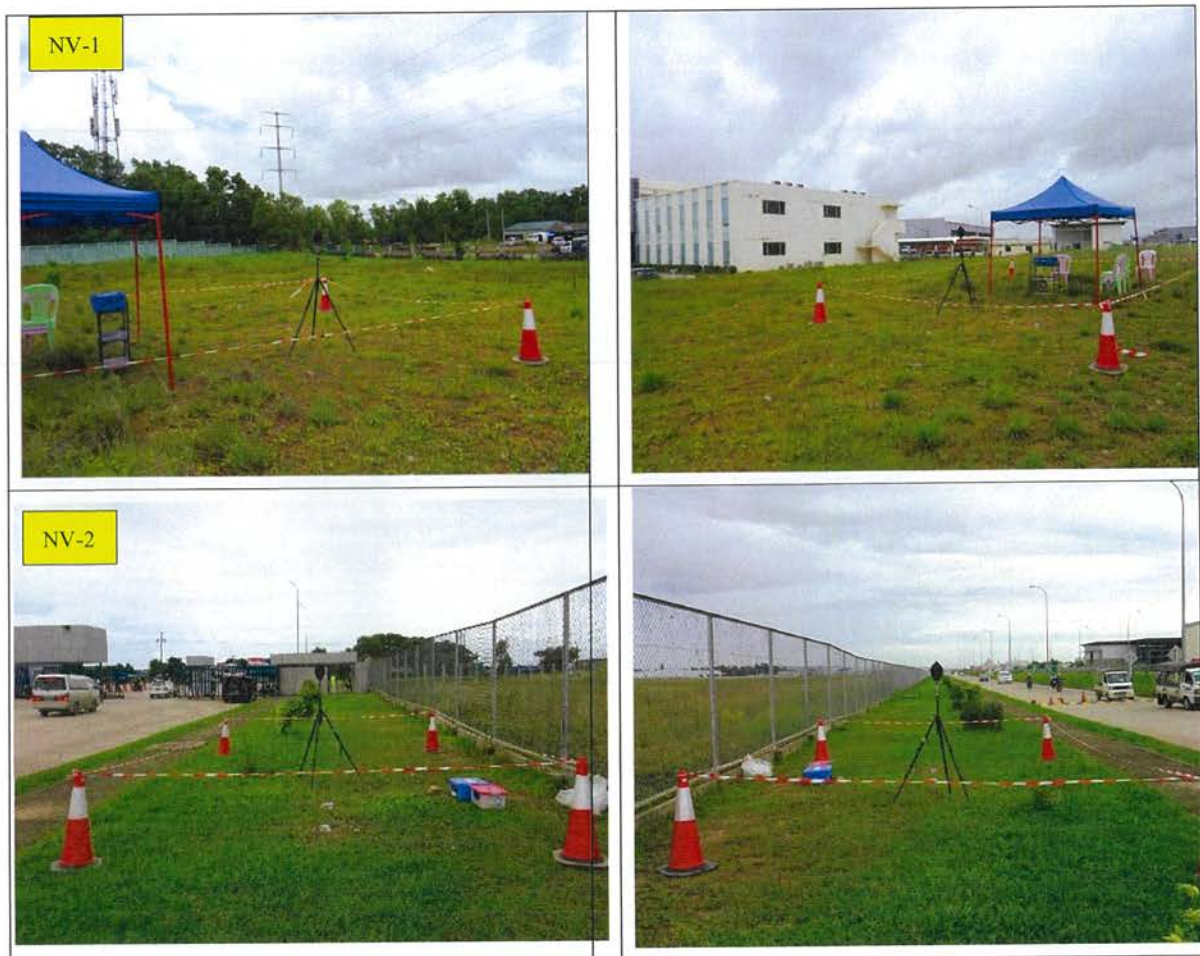
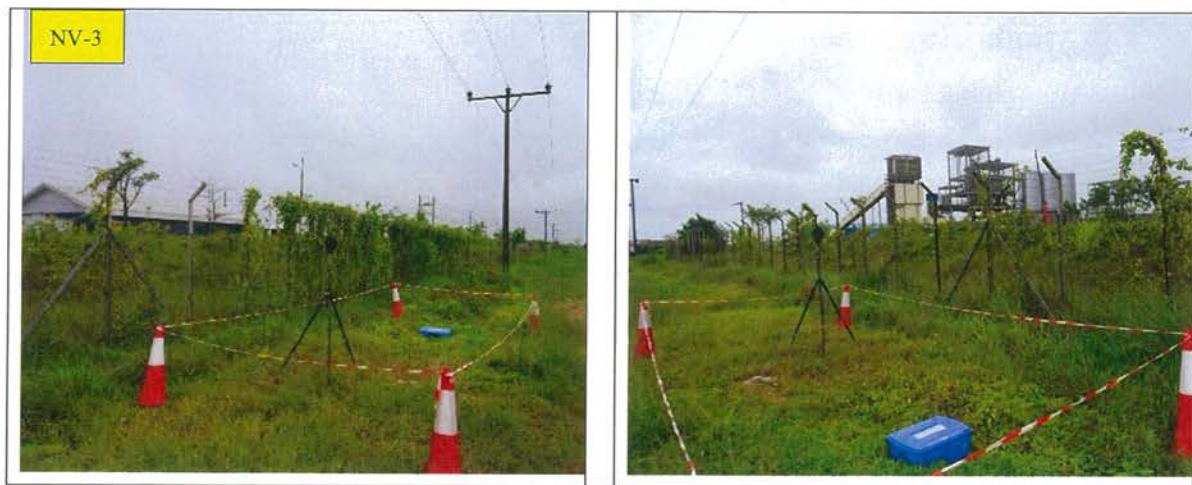
Figure 2.3-2 Status of Noise and Vibration Level Monitoring at NV-1, NV-2 and NV-3

Noise level was measured by “Rion NL-42 sound level meter” and automatically recorded every 10 minutes in a memory card. The vibration level meter was, VM-53A (Rion Co. Ltd., Japan), accompanied by a 3-axis accelerometer PV-83C (Rion Co. Ltd.) was placed on solid soil ground. Vertical vibration (Z axis), L_v , was measured every 10 minutes within the adaptable range of (10-70) dB at NV-1, (10-70) dB at NV-2, and (10-70) dB at NV-3 and recorded to a memory card.

The measurement period of noise and vibration was 24 hours for each monitoring point. The status of the noise and vibration level monitoring on NV-1, NV-2 and NV-3 are shown in Figure 2.3-1.

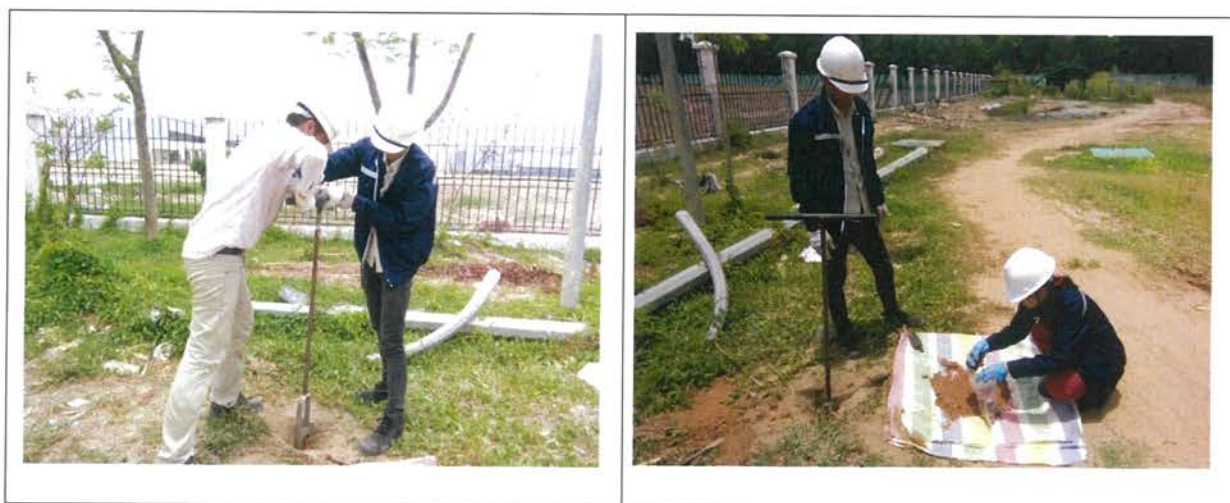
Figure 2 Soil quality sampling at S-1

S-1 is situated in the southern part of the Thilawa SEZ Zone (A) area, and distanced about 40 m from administration building. It was collected beside of the Trash Storage Building. Sometimes, wastewater after cleaning that domestic waste is leaked and may sink into the ground. The soil condition is fine to medium grained, reddish brown colored silty clay.

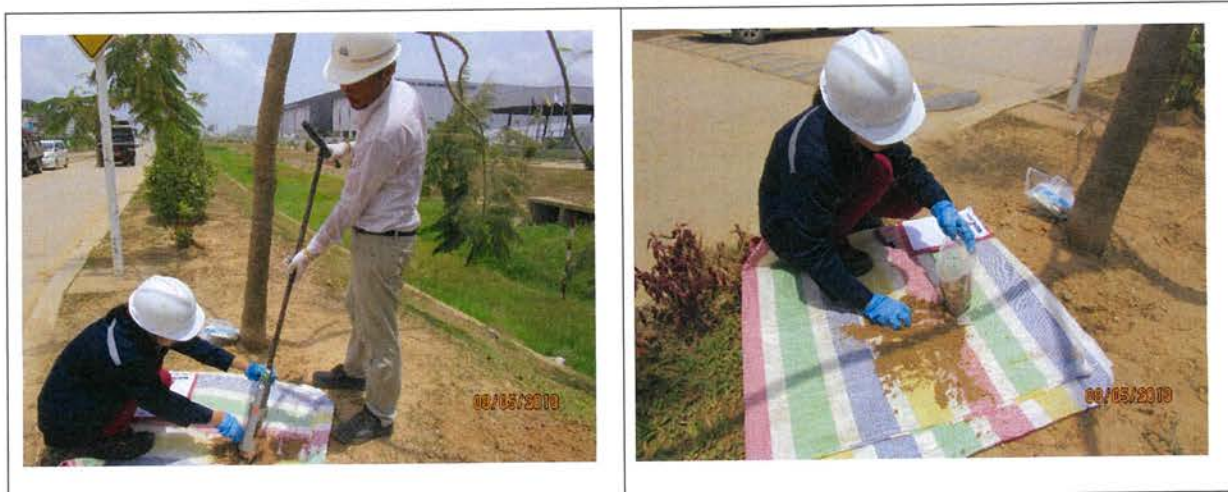
Figure 3 Soil quality sampling at S-2

S-2 was collected at the slope area of the retention canal, which is situated near the main gate of Thilawa SEZ (Zone-A). It is beside of the Thilawa SEZ car road and intended to plant the trees along the slop. The soil condition is fine to medium grained, reddish brown colored silty caly.

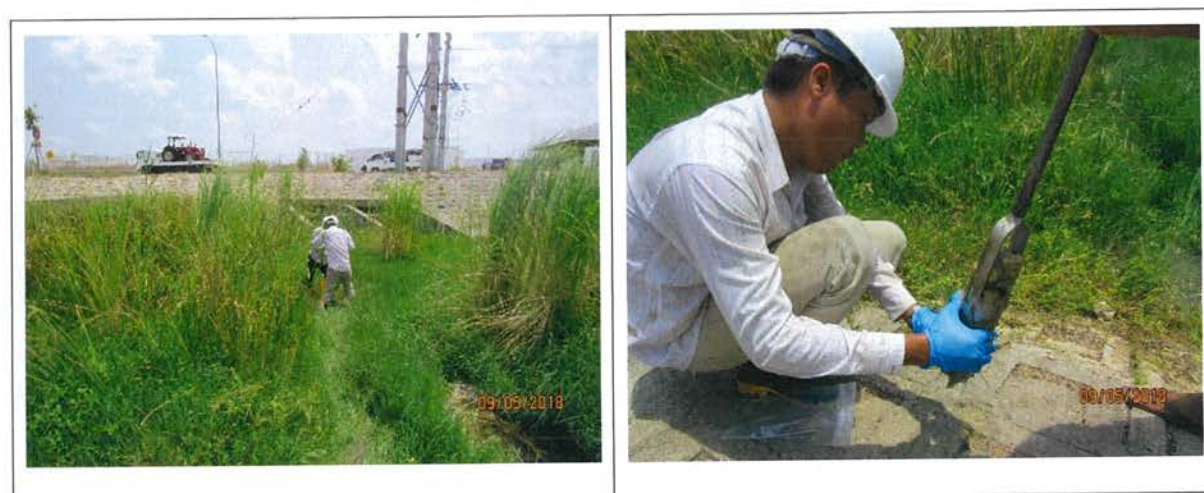
Figure 4 Soil quality sampling at S-3

S-3 is collected in the retention canal where wastewater from the centralized sewage treatment plant is flowing into the retention canal. It is distanced about 5 m away from the junction of wastewater discharge drainage and main rain water drainage. The soil condition is fine to medium grained, yellowish brown colored silty clay.

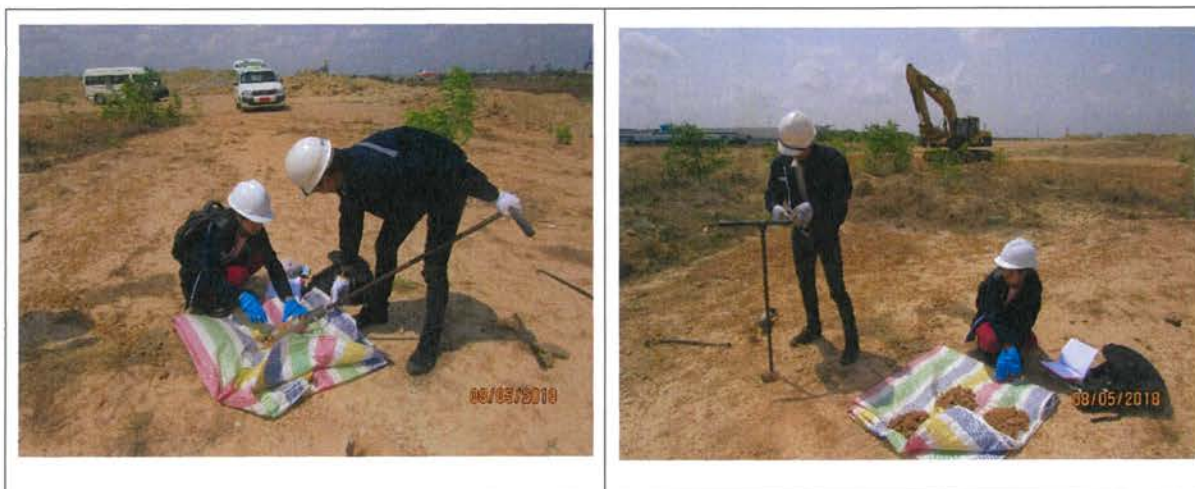
Figure 5 Soil quality sampling at S-4

S-4 is collected from the soil disposing site which is located near Plot No.E-1 of TSEZ Zone-A retention pond, about 40 m in distance. This dumping site is about 16,500 square meters where soil from Thilawa SEZ Zone-A (Phase-2). The soil condition is fine to medium grained, reddish brown colored silty caly.

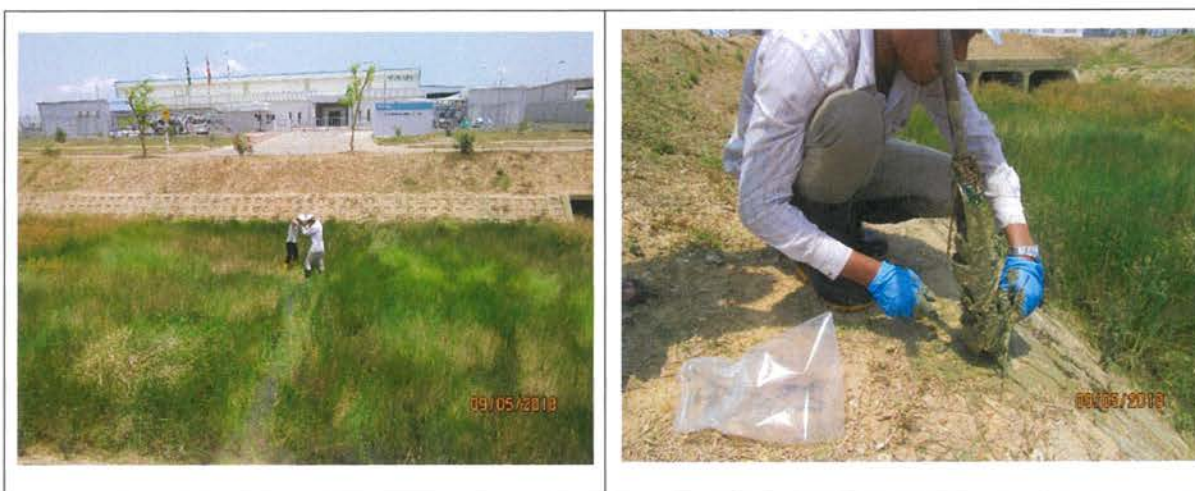
Figure 6 Soil quality monitoring at S-5

It is collected at the retention canal where wastewater is discharged from the retention pond of Plot No.E-1 of Thilawa SEZ Zone-A. S-5 is distanced about 100 m from this retention pond. The soil condition is fine grained, yellowish brown colored silty clay.
