Thilawa Special Economic  
Zone (Zone B) Development

## Environmental Monitoring Report Phase-3 and 4 (Construction Phase)

Myanmar Japan Thilawa  
Development Limited.

September 2020

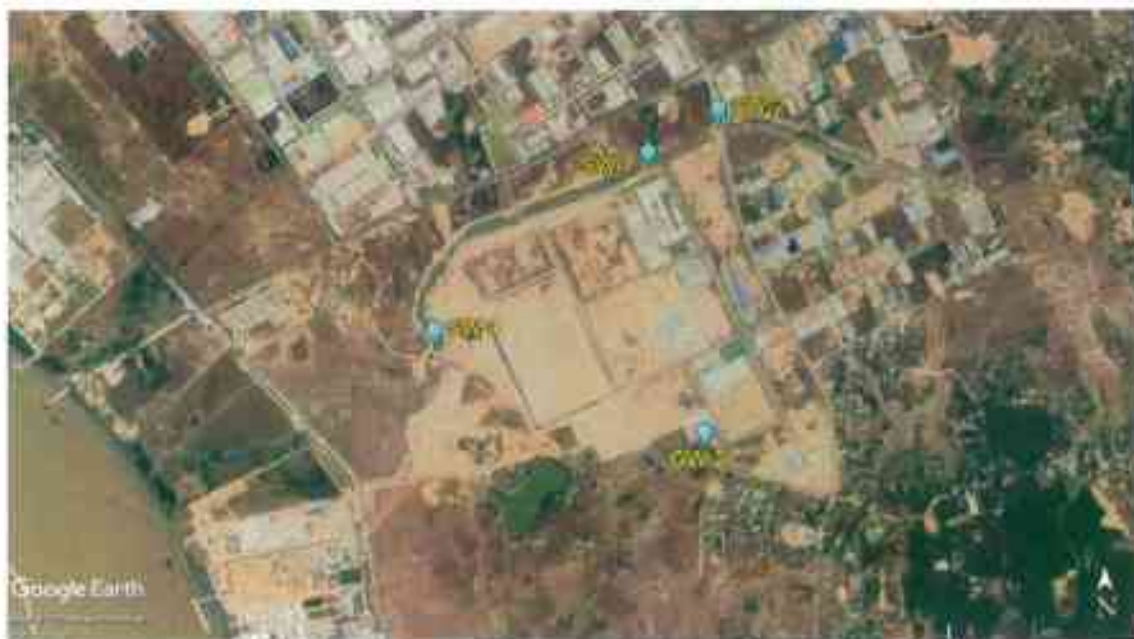
Thilawa Special Economic Zone (SEZ) is located in southern district of Yangon region and about 23 km southeast of Yangon city. As the developer of Thilawa SEZ, Myanmar Japan Thilawa Development Ltd. (MJTD) has a responsibility to carry out regular monitoring in the industrial area of Zone B in accordance with the approved Environmental Impact Assessment (EIA) report and Environmental Management Plan (EMP). MJTD has implemented monitoring various environmental items with the specified time frame to know the environmental conditions in and around the area. As for the monitoring of the water quality, total four sampling points are set for water quality survey, named SW-2, SW-4, SW-7 and GW-2 have been monitored in Thilawa SEZ and its surrounding area in timely manner. Among the four locations, SW-7 is main discharged point of Zone B during the construction stage. Moreover, GW-2 is monitored as a reference of existing tube well which located in the monastery compound of Phalan village. Location of sampling points for water quality monitoring is shown in Figure 1.1-1.

Figure 1.1-1 Location of Sampling Points of Water Quality Monitoring

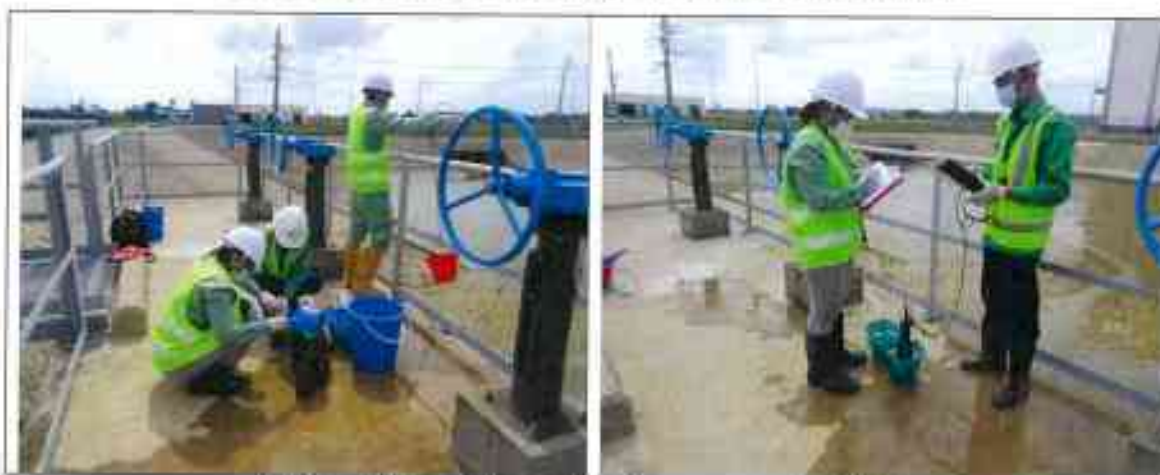
As the comparison with the target value, the results of Suspended Solid (SS), Total Dissolved Solids (TDS), total coliform and iron exceeded the target value. As for the result of SS, results at the surface water monitoring points (SW-2, SW-4 and SW-7) exceeded the target value. As for the result of TDS, results at the surface water monitoring point (SW-4 and SW-7) exceeded the target value. The exceed results for SS and TDS maybe due to three expected reasons; i) soil erosion caused by construction of factories in Zone B and eroded soil particles may contain soluble compounds that can dissolve in water, ii) delivered from upstream area such as natural origin and wastewater from local industrial zone outside of Thilawa SEZ, and iii) influence by water from the downstream due to flow back by tidal fluctuation.

Surface water sampling and onsite measurement at SW-7

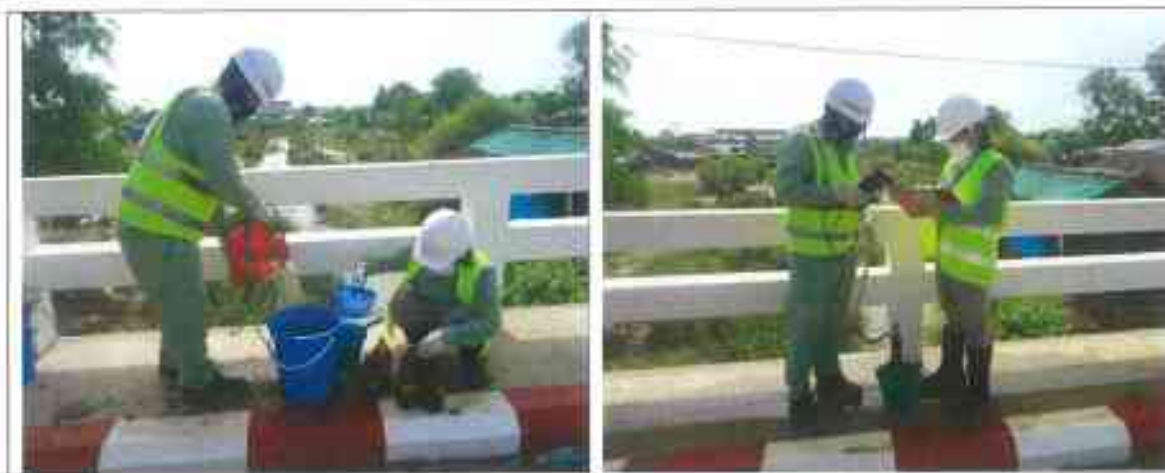
<sup>3</sup>Remark: For the monitoring point of SW-2, SW-4 and SW-7, the result of SS exceeded and SW-4 and SW-7 the result of TDS exceeded than the target value due to three expected reasons i) soil erosion caused by construction of factories in Zone-B and eroded soil particles may contain soluble compounds that can dissolve in water ii) delivered from upstream area such as natural origin and wastewater from local industrial zone outside of Thilawa SEZ, and iii) influence by water from the downstream due to flow back by tidal fluctuation.

Surface water sampling and onsite measurement at SW-2

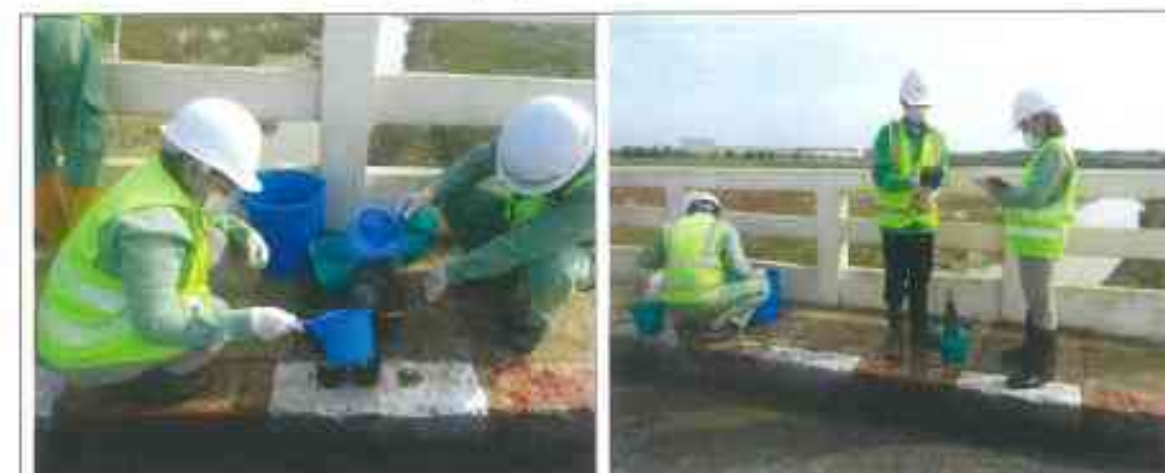
Surface water sampling and onsite measurement at SW-4

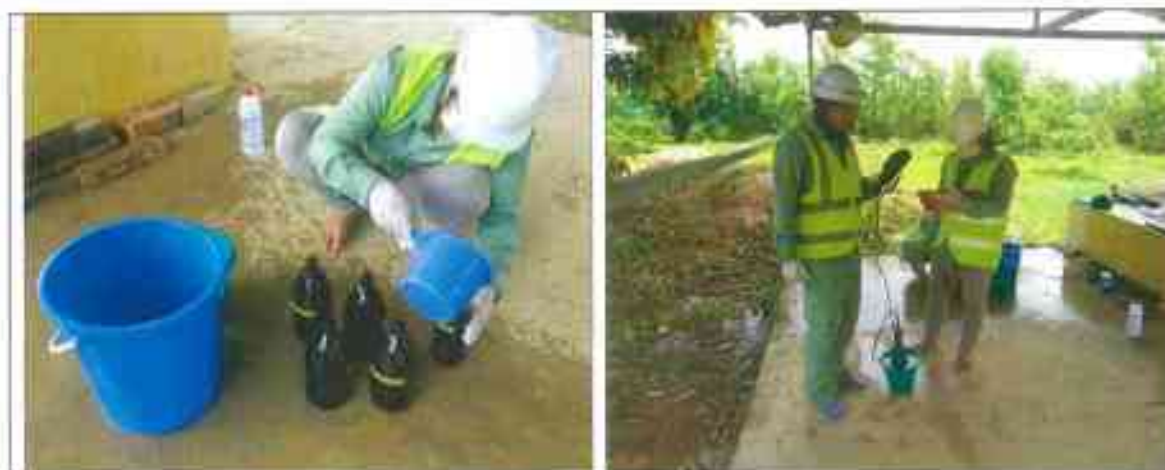
As for the result of the iron, the result at the monitoring point of reference tube well (GW-2) slightly exceeded the target value. It may be due to the corrosion of pipes because the water is pumped through the iron pipelines buried underneath the ground.

Ground water sampling and onsite measurement at GW-2

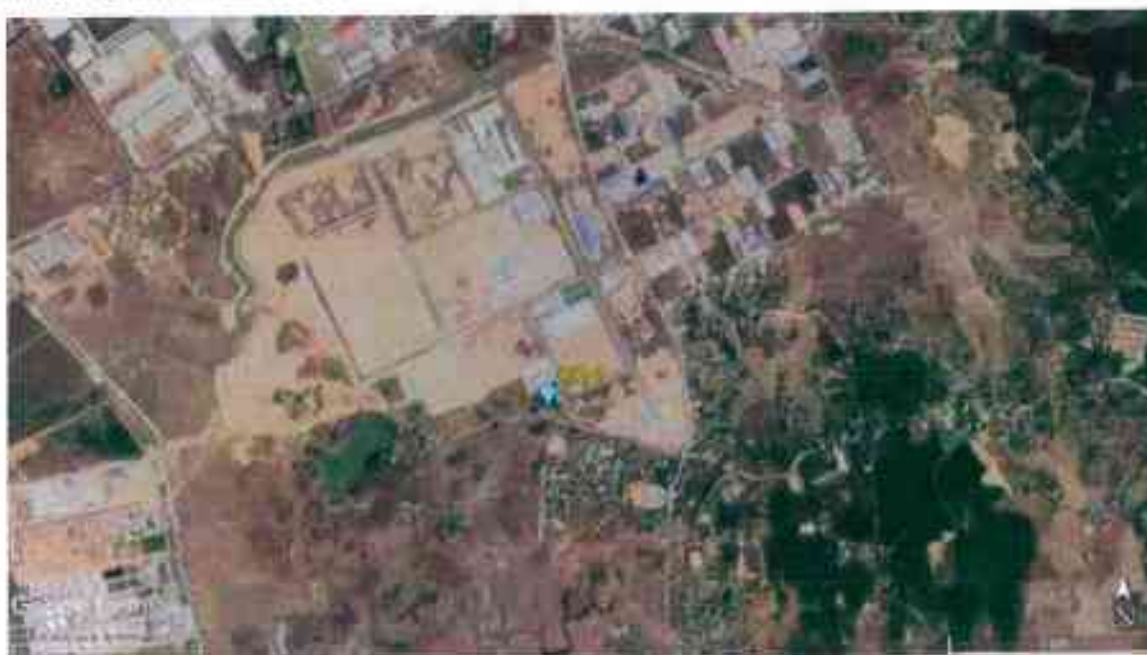
The air quality measurement equipment, "Haz-Scanner Environmental Perimeter Air Station (EPAS)" was set up at the south of the Thilawa SEZ Zone B, N: 16°39'24.20", E: 96°17'15.80", inside the monastery compound of Phalan village, surrounded by the residential houses of Phalan village in the south and fields in west, Thilawa SEZ Zone A in north, local Thilawa Industrial Zone in northeast and construction of Thilawa SEZ Zone B in east, north, north-northwest, northwest and northeast respectively. The air quality monitoring is carried out above location where is near to the residential houses of Phalan village. Possible emission sources are dust emissions from construction activities and exhaust gas emissions from construction fuel-burning equipment and daily human activities in Phalan village. The location of air quality monitoring is shown in the Figure 2.2-1.

Figure 2.2-1 Location of Air Quality Monitoring Point

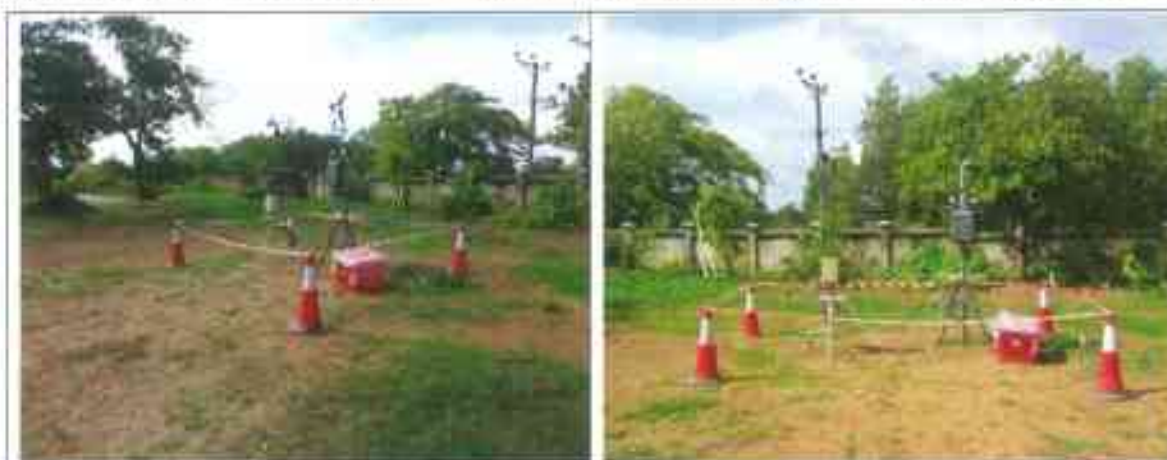
Figure 2.4-1 Status of Air Quality Monitoring Point

Monitoring of CO, NO<sub>2</sub>, PM<sub>2.5</sub>, PM<sub>10</sub> and SO<sub>2</sub> were conducted by referring to the recommendation of the United States Environmental Protection Agency (U.S. EPA). The Haz-Scanner EPAS was used to collect ambient air pollutants. The EPAS measures automatically every one minute and directly reads and records onsite for CO, NO<sub>2</sub>, PM<sub>2.5</sub>, PM<sub>10</sub> and SO<sub>2</sub>. The state of air quality monitoring is shown in Figure 2.4-1.

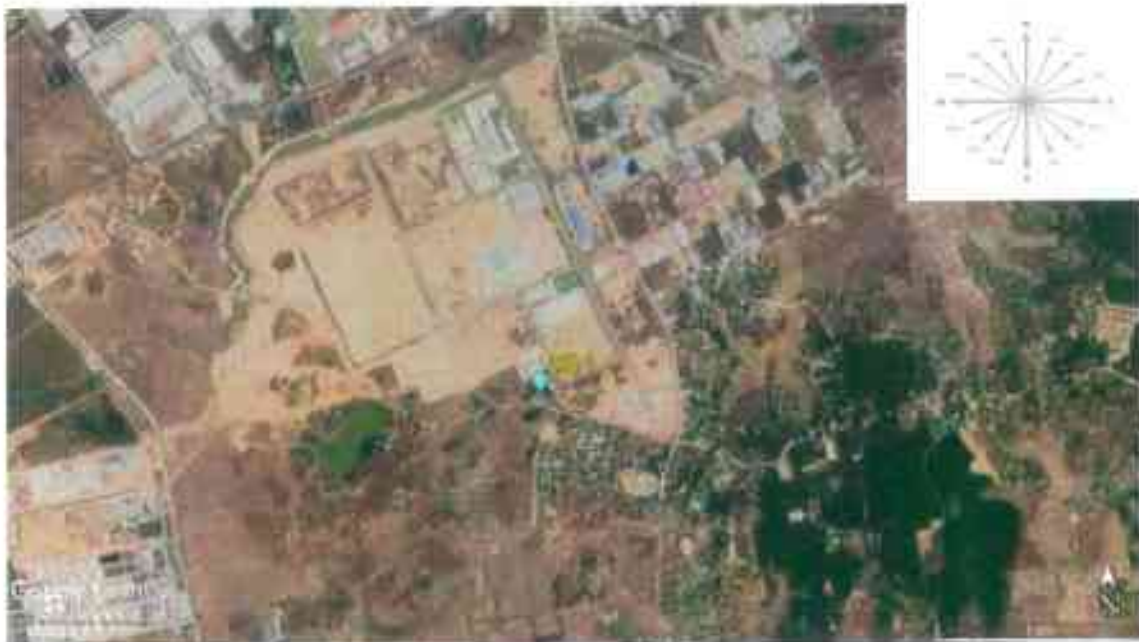
**Figure 2.5-1 Status of Air Quality Monitoring Point and Wind Direction**

Wind direction and wind speed were measured at AQ-1. Hourly average values of measured wind direction and wind speed data are described in Appendix-1. Status of air quality monitoring point and wind direction are described in Figure 2.5-1. Depending on the wind direction, West-Northwest (WNW), Northwest (NW), North-Northwest (NNW), North (N), North-Northeast (NNE), Northeast (NE), East-Northeast (ENE) and East (E) directions are assumed to come from the construction site of Zone B.

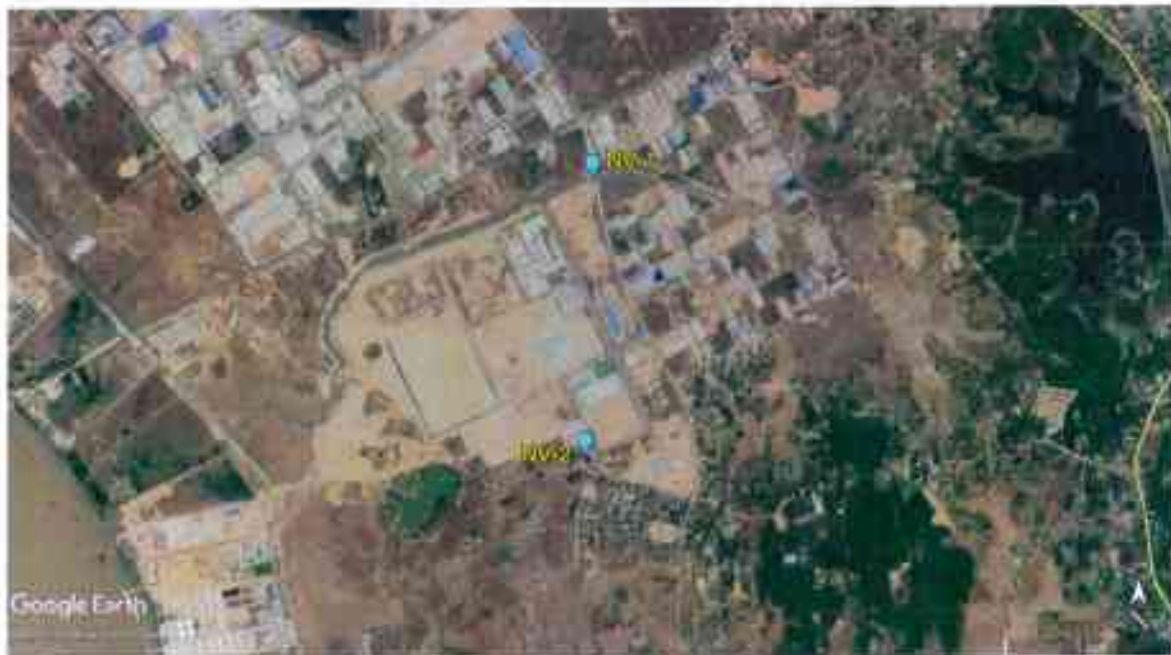
Noise and vibration levels were measured in the northeast corner of the Thilawa SEZ Zone B, monitoring point (NV-1); N: 16°40'18.22", E: 96°17'18.18" for traffic noise concerned and in the south of the Thilawa SEZ Zone B, monitoring point (NV-2); N: 16°39'24.90", E: 96°17'16.70", inside the monastery compound of Phalan village. The location of the noise and vibration monitoring points are shown in Figure 2.2-1.

Figure 2.2-1 Location of Noise and Vibration Level Monitoring Points

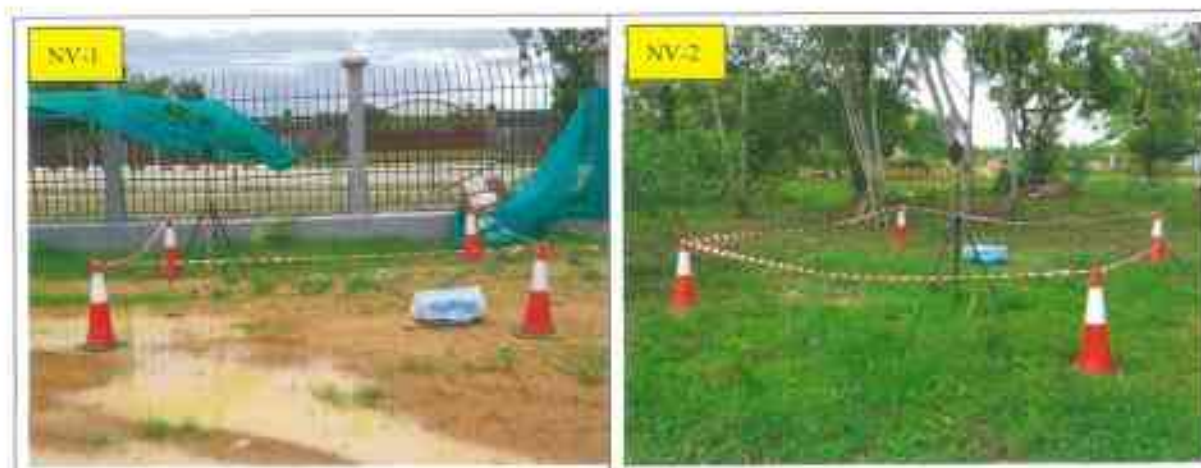
Figure 2.3-1 Status of Noise and Vibration Level Monitoring at NV-1 and NV-2

Noise level was measured by "Rion NL-42 sound level meter" and automatically records every 10 minutes in a memory card. The vibration level meter, VM-53A (Rion Co., Ltd., Japan), was accompanied by a 3-axis accelerometer PV-83C (Rion Co., Ltd.) and it was placed on solid soil ground. Vertical vibration (Z axis),  $L_v$ , was measured every 10 minutes within the adaptable range of (10-70) dB at NV-1 and (10-70) dB at NV-2 and recorded to a memory card.

The measurement period of noise and vibration was 24 hours for each monitoring point. The status of the noise and vibration level monitoring on NV-1 and NV-2 are shown in Figure 2.3-1.

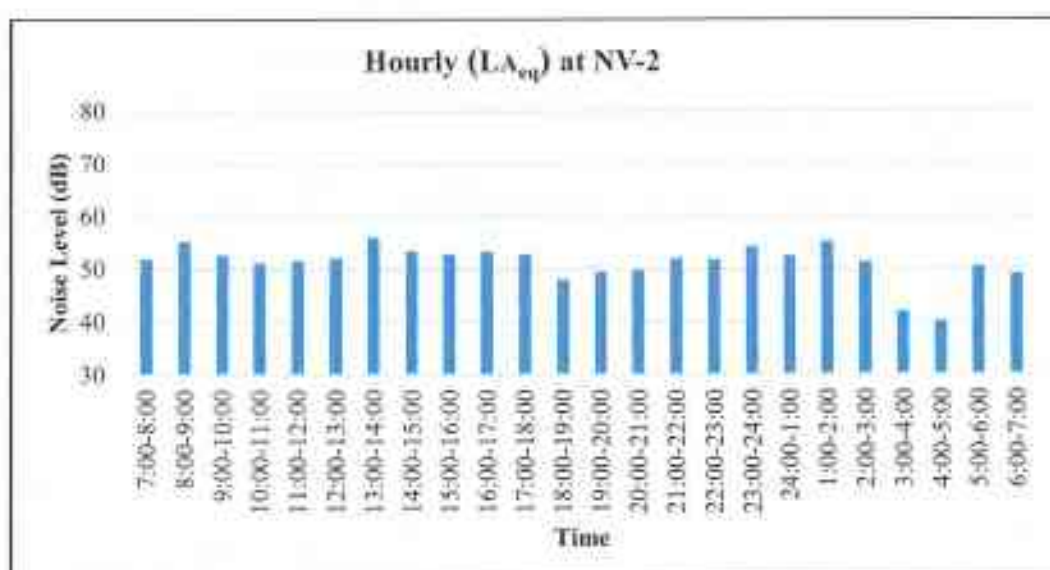
**Figure 2.4-2 Results of Noise Levels ( $L_{Aeq}$ ) Monitoring at NV-2**

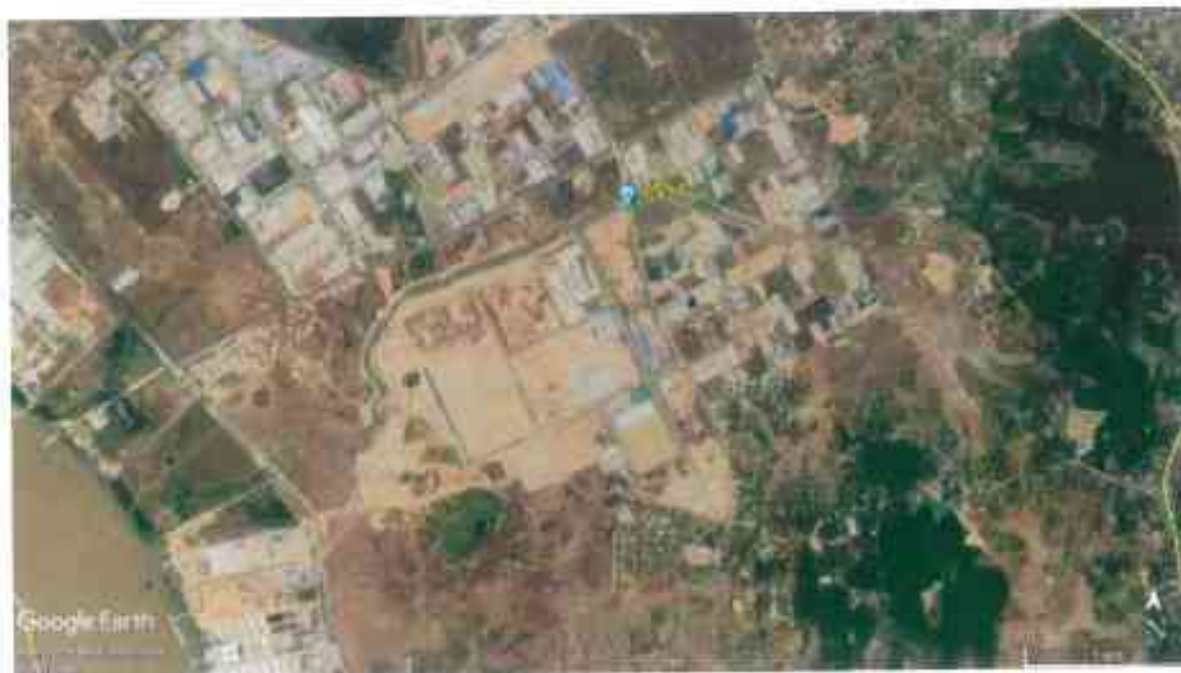
Traffic volume was measured at the northeast corner of the Thilawa SEZ Zone B, monitoring point (TV-1); N: 16°40'17.90", E: 96°17'18.20". The location of the traffic volume monitoring point is shown in Figure 2.2-1.

Figure 2.2-1 Location of Traffic Volume Monitoring Point

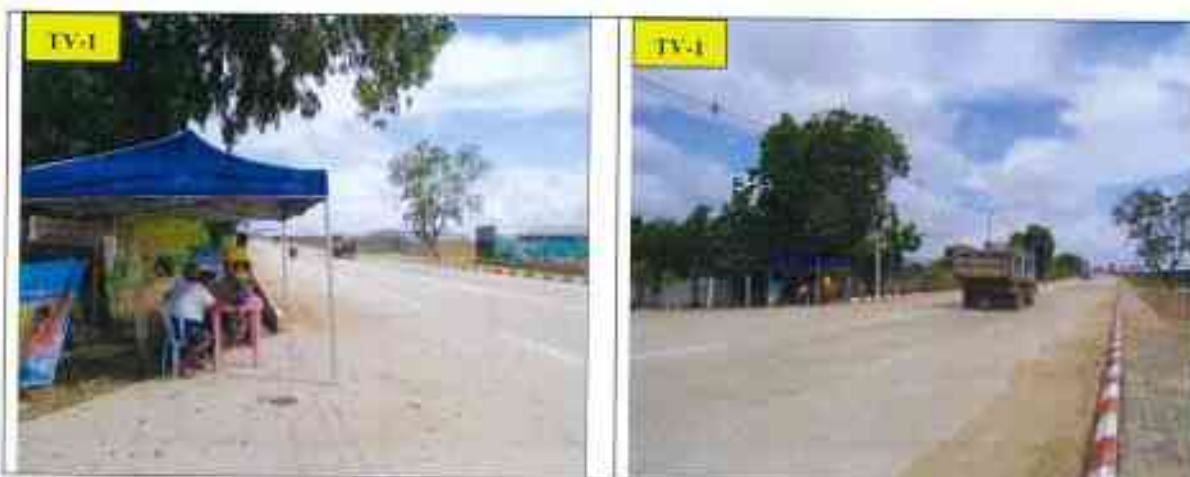
Figure 2.3-1 Status of Traffic Volume Monitoring at TV-1

The traffic volume monitoring was conducted for 24 hours at the same time as the traffic noise and vibration level monitoring. Traffic volume monitoring was conducted to count the number of vehicles moving in each direction. Manual count method was used and data was recorded using tally sheets. The status of the traffic volume monitoring on TV-1 is shown in Figure 2.3-1.

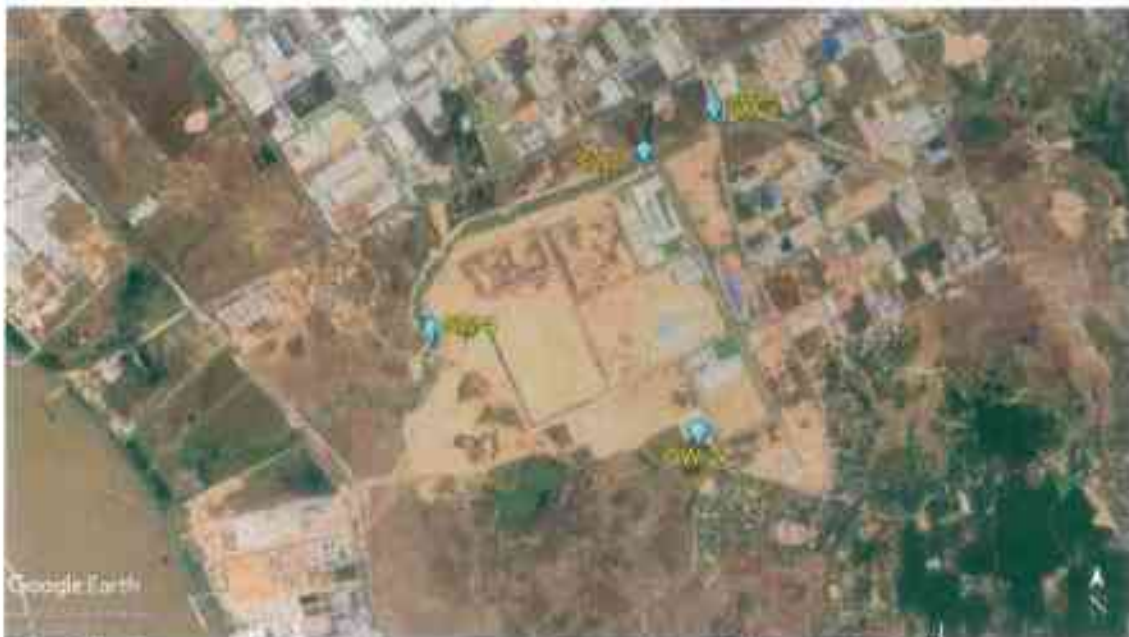
ရေအရည်အသွေးစောင့်ကြည့်လေ့လာမှုအား စစ်တမ်းကောက်ယူရာတွင် သီလဝါအထူးစီးပွားရေးဇုန်အတွင်းနှင့် အနီးပတ်ဝန်းကျင်ရှိ စုစုပေါင်းနေရာ လေးနေရာ၊ နာမည်အားဖြင့် မြေပေါ်ရေနမူနာယူသည့် နေရာ-၂ (SW-2)၊ မြေပေါ်ရေနမူနာယူသည့် နေရာ-၄ (SW-4)၊ မြေပေါ်ရေနမူနာယူသည့် နေရာ-၇ (SW-7) နှင့် မြေအောက်ရေနမူနာယူသည့် နေရာ-၂ (GW-2) တို့တွင် စောင့်ကြည့်လေ့လာခဲ့ပါသည်။ ထိုနေရာ လေးနေရာမှ မြေပေါ်ရေနမူနာယူသည့် နေရာ-၇ (SW-7) သည် ဇုန်အပိုင်း(ခ) ဆောက်လုပ်ရေးကာလတွင် အဓိကစွန့်ထုတ်ရေထွက်ပေါက် ဖြစ်ပါသည်။ ထို့အပြင် မြေအောက်ရေနမူနာယူသည့် နေရာ-၂ (GW-2) အား ဗလမ်းကျေးရွာတွင်တည်ရှိသော ဘုန်းကြီးကျောင်းပရဝဏ်အတွင်းရှိ ရေတွင်းအား ရည်ညွှန်းနိုင်ရန် စောင့်ကြည့်လေ့လာခဲ့သည်။ ရေအရည်အသွေးစောင့်ကြည့်လေ့လာမှုအတွက် နမူနာရယူသော နေရာများ၏ တည်နေရာများကို ပုံ ၁.၁-၁ တွင် မော်ပြထားပါသည်။

ပုံ ၁.၁-၁ ရေအရည်အသွေးစောင့်ကြည့်လေ့လာမှုအတွက်နမူနာရယူသောနေရာများ၏ တည်နေရာပြပုံ

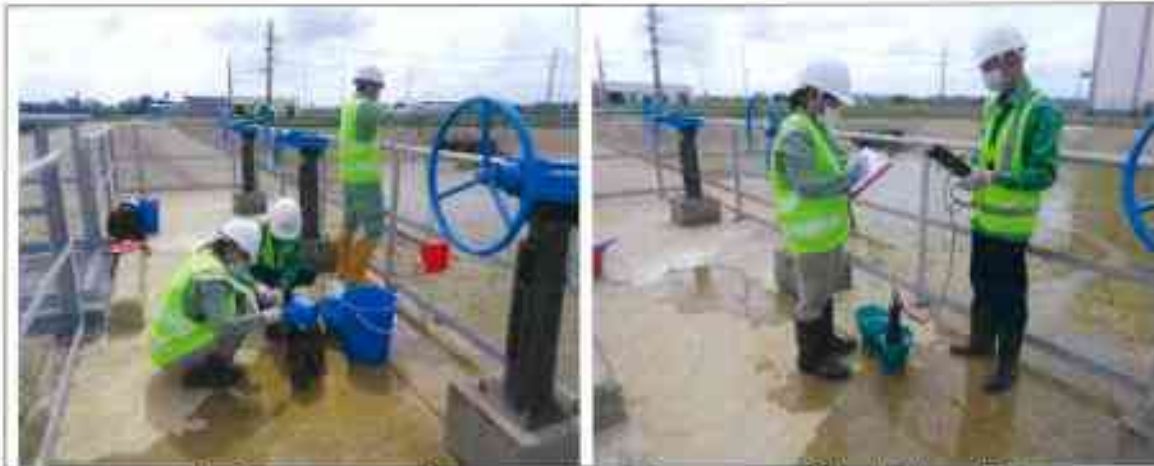
မြေပေါ်ရေစုမူနာယူသည့် နေရာ-၇ (SW-7) ၌ ရေစုမူနာယူခြင်းနှင့်တိုင်းတာခြင်း

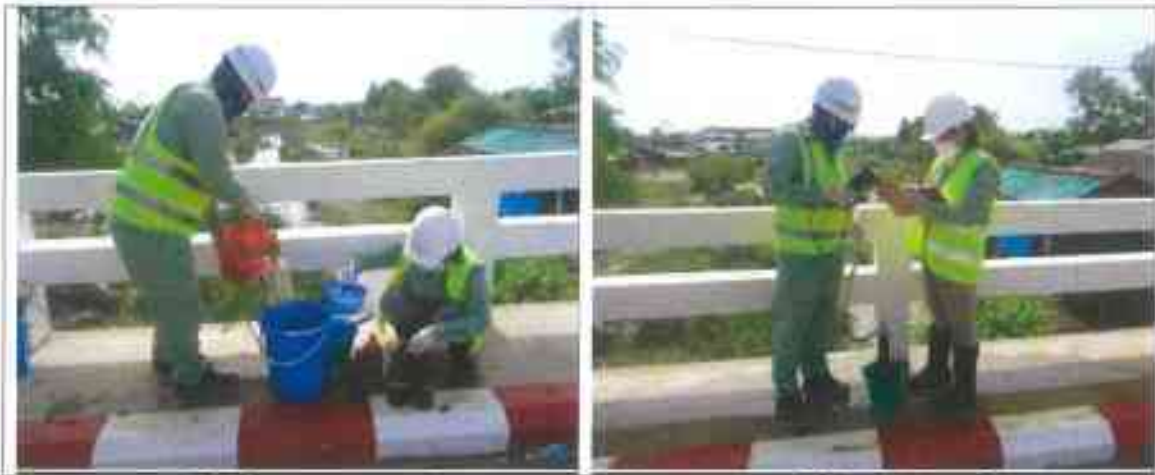
မြေပေါ်ရေနမူနာယူသည့် နေရာ-၂ (SW-2) ၌ ရေနမူနာရယူခြင်းနှင့်တိုင်းတာခြင်း

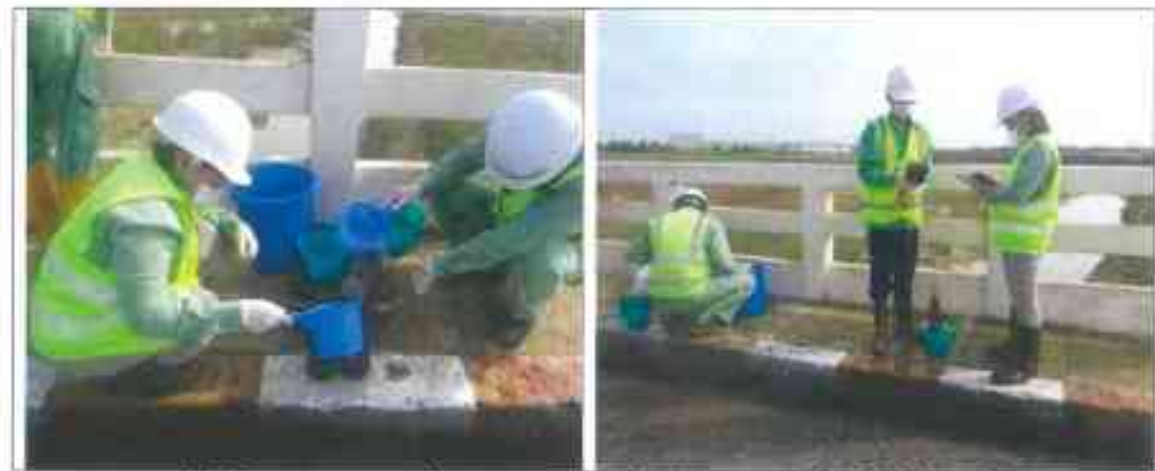
မြေပေါ်ရေနမူနာယူသည့် နေရာ-၄ (SW-4) ၌ ရေနမူနာရယူခြင်းနှင့်တိုင်းတာခြင်း

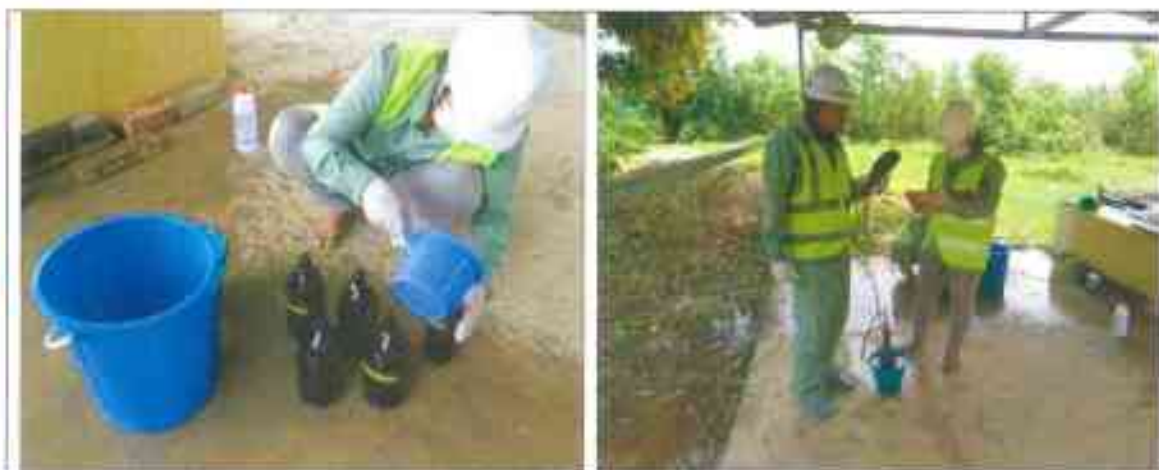
မြေအောက်ရေနမူနာယူသည့် နေရာ-၂ (GW-2) ရေနမူနာရယူခြင်းနှင့်တိုင်းတာခြင်း

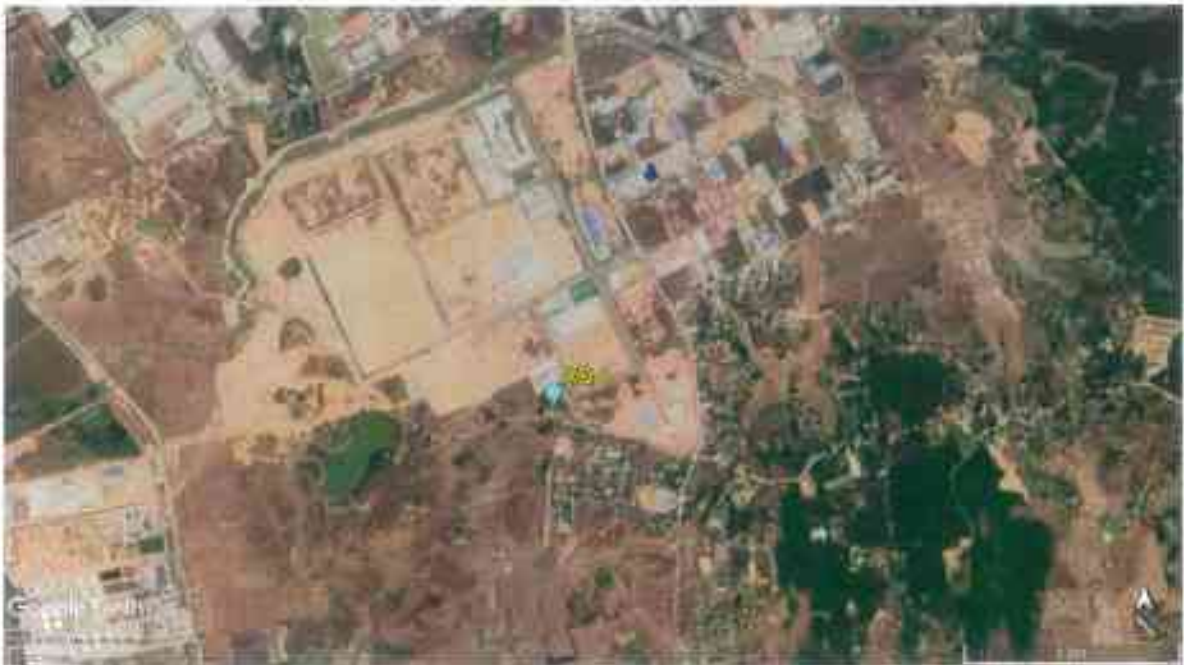
ပတ်ဝန်းကျင်လေထုအရည်အသွေးတိုင်းတာသည့် စက်ကိရိယာဖြစ်သည့် "Haz-Scanner Environmental  
Perimeter Air Station (EPAS)" ဖြင့် သီလဝါအထူးစီးပွားရေးဇုန်၏ တောင်ဘက်၊ မြောက်လတ္တီတွဒ်  
၁၆°၃၉'၂၄.၂၀"၊ အရှေ့လောင်ဂျီတွဒ် ၉၆°၁၇'၁၅.၈၀"၊ ဖလမ်းကျေးရွာ၊ ဖလမ်းရွာခွဲ၊ ကျောင်းဝန်းထဲတွင်  
တပ်ဆင်ထားပြီး တောင်ဘက်တွင် ဖလမ်းကျေးရွာရှိလူနေအိမ်များ၊ အနောက်ဘက်တွင် လယ်ကွင်းများ၊  
မြောက်ဘက်တွင် သီလဝါအထူးစီးပွားရေးဇုန်အပိုင်း(က)၊ အရှေ့မြောက်ဘက်တွင် ပြည်တွင်းသီလဝါဧကမူစုနှင့်  
အရှေ့၊ မြောက်၊ မြောက်-အနောက်မြောက်၊ အနောက်မြောက် နှင့် အရှေ့မြောက်ဘက်တို့တွင် တည်ဆောက်ဆဲ  
သီလဝါအထူးစီးပွားရေးဇုန် အပိုင်း(ခ)တို့ဖြင့် ဝန်းရံထားသည်။ လေထုအရည်အသွေး စောင့်ကြည့်လေ့လာမှုကို  
ဖလမ်းကျေးရွာရှိ လူနေအိမ်များနှင့် အနီးဆုံးနေရာဖြစ်သော အထက်ပါနေရာ၌ ဆောင်ရွက်ခဲ့သည်။  
အဓိကလေထုညစ်ညမ်းမှုကို ဖြစ်နိုင်သောစွန့်ထုတ်ဓာတ်ငွေ့များ ထုတ်လွှတ်ရာ အရင်းအမြစ်များမှာ  
ဆောက်လုပ်ရေးလုပ်ငန်းစဉ်များမှ ဖုန်များထွက်ရှိခြင်း၊ ဆောက်လုပ်ရေးလုပ်ငန်းသုံး ယာဉ်များနှင့် ဖလမ်းကျေးရွာရှိ

ပုံ ၂.၂-၁ လေထုအရည်အသွေးစောင့်ကြည့်လေ့လာသည့်တည်နေရာ

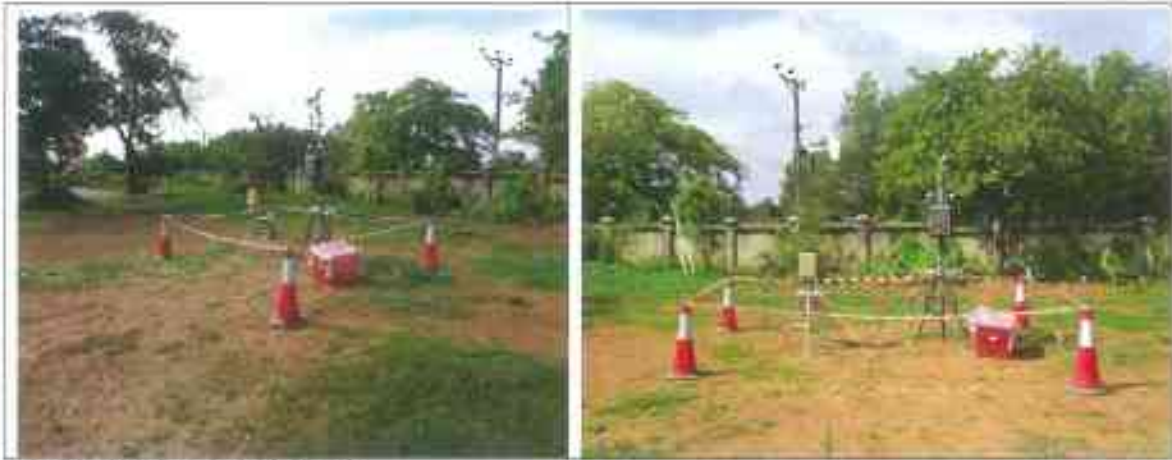
ပတ်ဝန်းကျင်လေထုအရည်အသွေး စံနမူနာရယူခြင်းနှင့် ဆန်းစစ်လေ့လာခြင်းများကို အမေရိကန် ပတ်ဝန်းကျင်ဆိုင်ရာ ထိန်းသိမ်းရေးအေဂျင်စီ (U.S. EPA) ၏ အကြံပြုချက်များကို ကိုးကား၍ ကာဗွန်မိုနောက်ဆိုဒ် (CO)၊ နိုက်ထရိုဂျင်ဒိုင်အောက်ဆိုဒ် (NO<sub>2</sub>)၊ အမှုန်အမွှား (PM<sub>2.5</sub>)၊ အမှုန်အမွှား (PM<sub>10</sub>) နှင့် ဆာလဖာဒိုင်အောက်ဆိုဒ် (SO<sub>2</sub>)တို့အား စောင့်ကြည့်လေ့လာမှုများ လုပ်ဆောင်ခဲ့သည်။ ပတ်ဝန်းကျင်လေထုအရည်အသွေးကို စောင့်ကြည့်တိုင်းတာ၍ အချက်အလက်ရယူရန်အတွက် The Haz-Scanner Environmental Perimeter Air Station (EPAS)ကို အသုံးပြုခဲ့ပါသည်။ လေထုအရည်အသွေး အချက်အလက်များကို တစ်မိနစ်တိုင်း အလိုအလျောက်တိုင်းတာသည့် အရည်အသွေးအမျိုးအစား၏ အချက်အလက်များ (ကာဗွန်မိုနောက်ဆိုဒ် (CO)၊ နိုက်ထရိုဂျင်ဒိုင်အောက်ဆိုဒ် (NO<sub>2</sub>)၊ အမှုန်အမွှား (PM<sub>2.5</sub>)၊ အမှုန်အမွှား (PM<sub>10</sub>) နှင့် ဆာလဖာဒိုင်အောက်ဆိုဒ် (SO<sub>2</sub>) ) ကို မှတ်တမ်းတင် သိမ်းဆည်းထားပါသည်။ လေထုအရည်အသွေး စောင့်ကြည့်လေ့လာသော အခြေအနေကို ပုံ ၂.၄-၁ တွင် ပြသထားပါသည်။

### ပုံ ၂.၄-၁ လေထုအရည်အသွေးစောင့်ကြည့်လေ့လာခြင်းအခြေအနေ

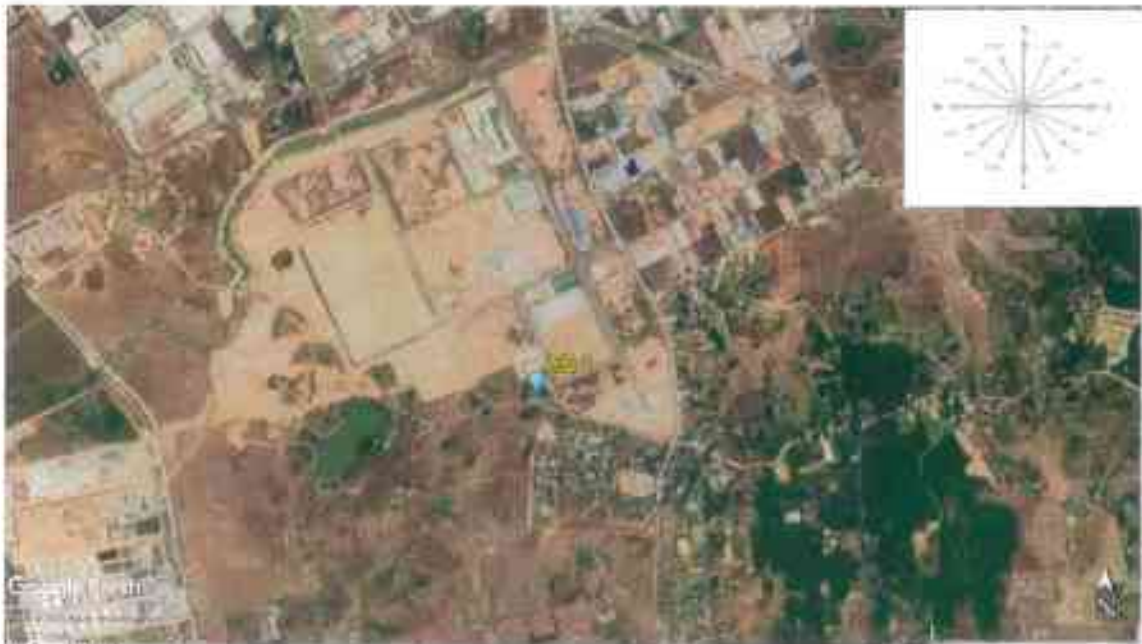
လေထုအရည်အသွေးစောင့်ကြည့်လေ့လာသည့် နေရာ-၁ (AQ-1)တွင် လေတိုက်ခတ်ရာအရပ်နှင့် လေတိုက်နှုန်းကို တိုင်းတာခဲ့ပါသည်။ တိုင်းတာထားသော လေတိုက်ခတ်ရာအရပ်နှင့် လေတိုက်နှုန်းတို့၏ တစ်နာရီပျမ်းမျှ တန်ဖိုးများကို နောက်ဆက်တွဲ-၁ တွင်ဖော်ပြထားပါသည်။ လေထုအရည်အသွေး စောင့်ကြည့်လေ့လာသော တည်နေရာ၏ အခြေအနေနှင့် လေတိုက်ခတ်ရာအရပ်တို့အား ပုံ၂.၅-၁တွင် ပြသထားပါသည်။ လေတိုက်ခတ်ရာအရပ်ပေါ်မှတည်၍ အနောက်-အနောက်မြောက် (WNW)၊ အနောက်မြောက်(NW)၊ မြောက်-အနောက်မြောက်(NNW)၊ မြောက်(N)၊ မြောက်-အရှေ့မြောက် (NNE)၊ အရှေ့မြောက်(NE)၊ အရှေ့-အရှေ့မြောက်(ENE) နှင့် အရှေ့(E) အရပ်တို့မှ တိုက်ခတ်သောလေမှာ ဇုန်အပိုင်း(ခ)၏ ဆောက်လုပ်ရေး လုပ်ငန်းခွင်မှ တိုက်ခတ်ကြောင်းခန့်မှန်းနိုင်ပါသည်။

### ပုံ ၂.၅-၁ လေထုအရည်အသွေးစောင့်ကြည့်လေ့လာသောတည်နေရာ နှင့် လေတိုက်ခတ်ရာအရပ်အခြေအနေ

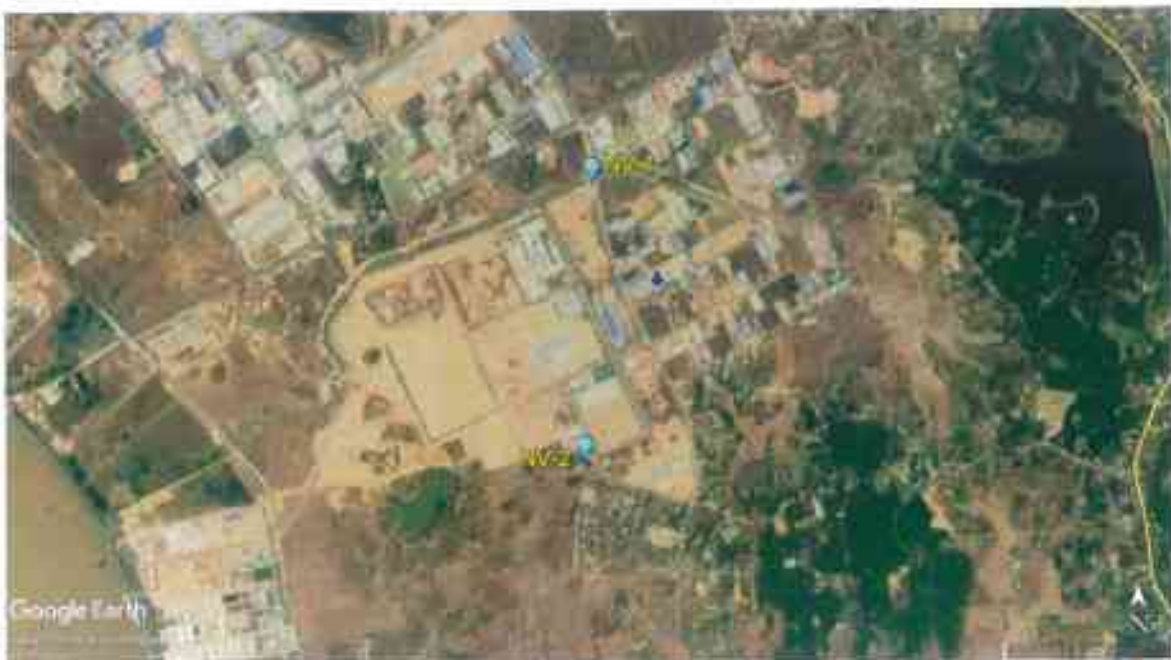
ယာဉ်သွားလာမှုကြောင့်ဖြစ်ပေါ်လာသော ဆည်သံနှင့်တုန်ခါမှုများကို အဓိကထားတိုင်းတာနိုင်ရန် သီလဝါအထူးစီးပွားရေးဇုန် အပိုင်း(ခ)၏ အရှေ့မြောက်ဘက်ထောင့် မြောက်လတ္တီတွဒ် ၁၆°၄၀'၁၈.၂၂"၊ အရှေ့လောင်ဂျီတွဒ် ၉၆°၁၇'၁၈.၁၈" တွင် စောင့်ကြည့်လေ့လာသည့် နေရာ-၁ (NV-1) နှင့် သီလဝါအထူးစီးပွားရေးဇုန် အပိုင်း(ခ)၏ တောင်ဘက် ဖလမ်းကျရွှေ၊ ဖလမ်းရွာဦးကျောင်းတိုက်အတွင်း မြောက်လတ္တီတွဒ် ၁၆°၃၉'၂၄.၉၀" ၊ အရှေ့လောင်ဂျီတွဒ် ၉၆°၁၇'၁၆.၇၀" တွင် စောင့်ကြည့်လေ့လာသည့် နေရာ-၂ (NV-2)ဟူ၍ ဆည်သံနှင့်တုန်ခါမှုအဆင့်များကို နှစ်နေရာ တိုင်းတာခဲ့ပါသည်။ ဆည်သံနှင့်တုန်ခါမှု စောင့်ကြည့် လေ့လာခဲ့သည့် တည်နေရာများကို ပုံ ၂.၂-၁ တွင် ပြသထားပါသည်။

ပုံ ၂.၂-၁ ဆည်သံနှင့်တုန်ခါမှု စောင့်ကြည့်လေ့လာသည့်တည်နေရာများ

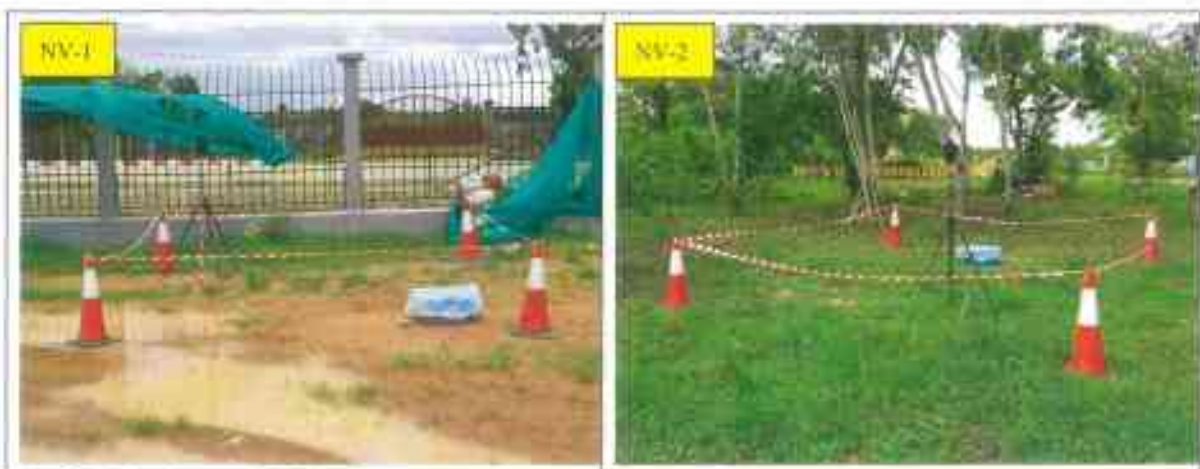
ဆူညံသံအဆင့်အား "Rion NL-42 အသံအဆင့်တိုင်းတာသည့်ကိရိယာ" ဖြင့်တိုင်းတာပြီး ၁၀မိနစ်တိုင်း အလိုအလျောက်တိုင်းတာပြီး စက်အတွင်းရှိ မန်မိုရီကဒ်အတွင်း မှတ်သားထားပါသည်။ တုန်ခါမှုအဆင့် တိုင်းတာသည့် ကိရိယာ "Rion VM-53A" ဝင်ရိုးသုံးခုပါဝင်သော တုန်ခါမှုအဆင့် သတ်မှတ်သည့် ကိရိယာအား မြေကြီးပေါ်တွင် ထားရှိပါသည်။ တုန်ခါမှု (L)အား နေရာ-၁ (NV-1)နှင့် နေရာ-၂ (NV-2)တို့၌ အလိုက်အသင့် ပြောင်းလဲနိုင်သောအဆင့် (၁၀-၇၀) dB အတွင်းထားရှိပြီး ၁၀ မိနစ်တိုင်း အလိုအလျောက် တိုင်းတာပြီး စက်အတွင်းရှိ မန်မိုရီကဒ်အတွင်း မှတ်သားထားပါသည်။

စောင့်ကြည့်လေ့လာသော နေရာတစ်ခုစီတွင် ဆူညံသံနှင့်တုန်ခါမှု စောင့်ကြည့်လေ့လာမှုအား ၂၄ နာရီ တိုင်းတာပါသည်။ နေရာ-၁ (NV-1) နှင့် နေရာ-၂ (NV-2) ရှိ ဆူညံသံနှင့်တုန်ခါမှုအဆင့် စောင့်ကြည့် လေ့လာသောအခြေအနေကို ပုံ ၂.၃-၁ တွင် ပြသထားပါသည်။

ပုံ ၂.၃-၁ ဆူညံသံနှင့်တုန်ခါမှုအဆင့် စောင့်ကြည့်လေ့လာမှုအခြေအနေ

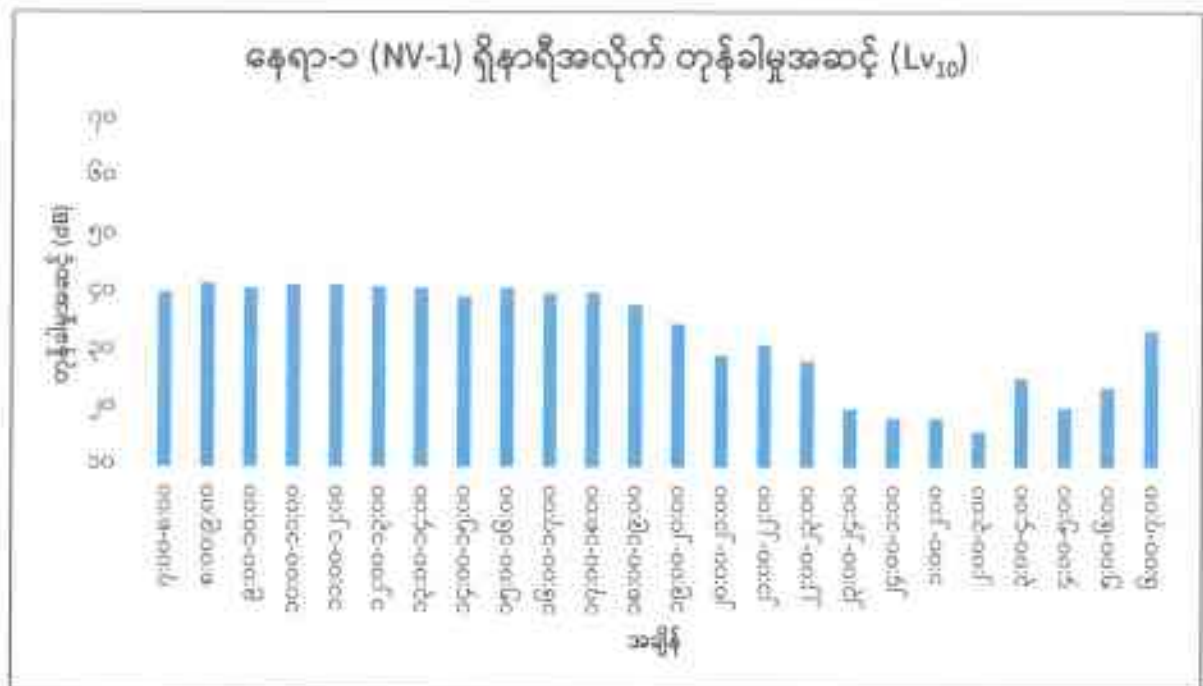
ပုံ၂.၄-၃ နေရာ-၁ (NV-1) ၏တုန့်ခါမှုအဆင့် စောင့်ကြည့်လေ့လာမှုရလဒ်

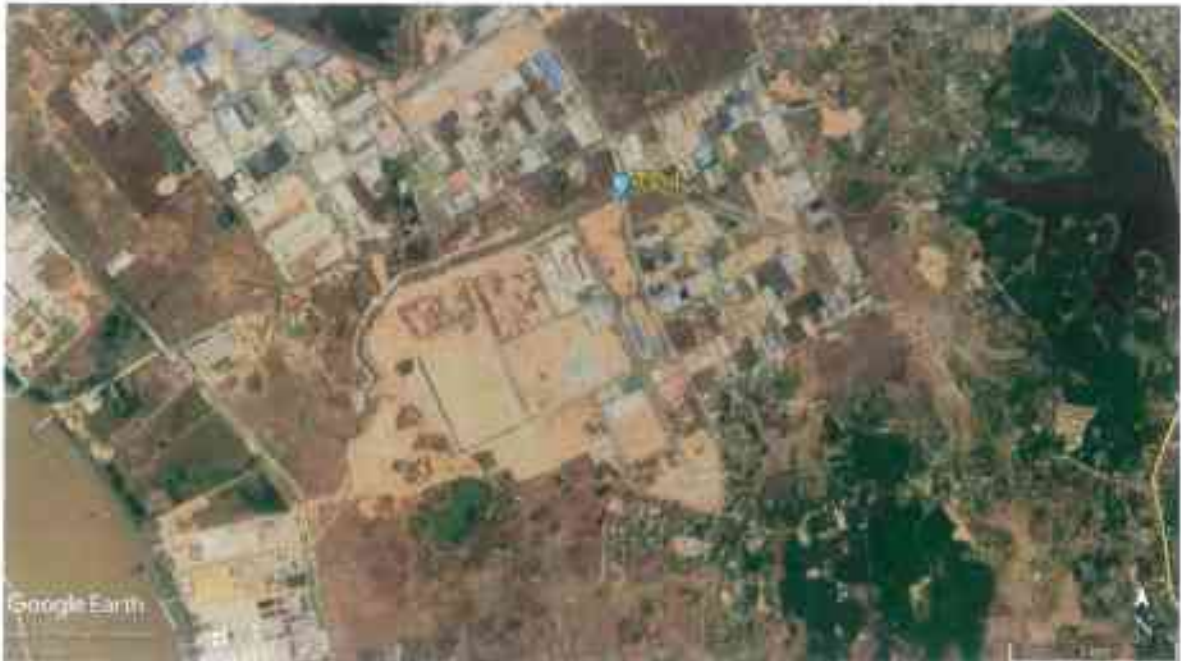
ယာဉ်သွားလာမှုနှုန်းအား သီလဝါအထူးစီးပွားရေးဇုန် အပိုင်း(ခ)၏ အရှေ့မြောက်ဘက်ထောင့်၊  
မြောက်လတ္တီတွဒ် ၁၆°၄၈'၁၇.၉၀" ၊ အရှေ့လောင်ဂျီတွဒ် ၉၆°၁၇'၁၈.၂၀" နေရာ၌ စောင့်ကြည့်လေ့လာခဲ့ပါသည်။  
ယာဉ်သွားလာမှုနှုန်း စောင့်ကြည့်လေ့လာသော တည်နေရာကို ပုံ ၂.၂-၁ တွင် ပြသထားပါသည်။

ပုံ ၂.၂-၁ ယာဉ်သွားလာမှုနှုန်း စောင့်ကြည့်လေ့လာသည့်တည်နေရာ

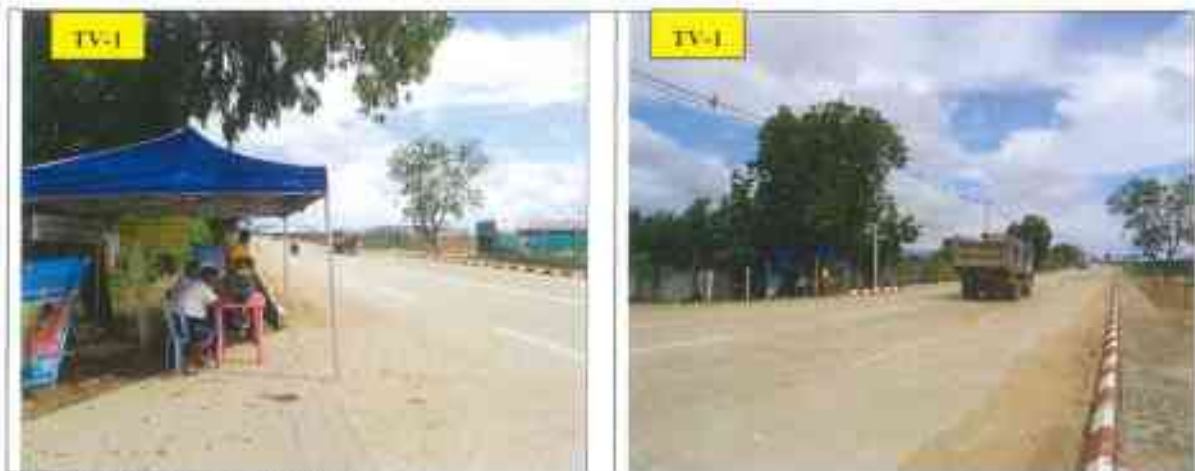
ယာဉ်သွားလာမှုနှုန်း စောင့်ကြည့်လေ့လာခြင်း ဆောင်ရွက်နေစဉ်တွင် ယာဉ်သွားလာမှုကြောင့် ဖြစ်ပေါ်နိုင်သော ဆူညံသံနှင့်တုန်ခါမှုတိုင်းတာခြင်းကိုပါ တစ်ပြိုင်နက်တည်း ၂၄ နာရီကြာ ဆောင်ရွက်ခဲ့ပါသည်။ ယာဉ်သွားလာမှုနှုန်း စောင့်ကြည့်လေ့လာမှုကို မလမ်းကျေးရွာမှ ဒဂုံ-သီလဝါလမ်းသို့ လာသော ယာဉ်အရေအတွက်နှင့် ဒဂုံ-သီလဝါလမ်းမှ မလမ်းကျေးရွာသို့ လာသောယာဉ်အရေအတွက် အသီးသီးကို ရေတွက်ခဲ့ပါသည်။ ယာဉ်အရေအတွက်ကို လူကိုယ်တိုင် တိုက်ရိုက်စောင့်ကြည့်၍ တာလီချိုးမှတ်သားခြင်းဖြင့် မှတ်သားခဲ့ပါသည်။ နေရာ-၁ (TV-1)၌ ယာဉ်သွားလာမှုနှုန်း စောင့်ကြည့်လေ့လာခြင်း အခြေအနေကို ပုံ ၂.၃-၁ တွင် ပြသထားသည်။

ပုံ ၂.၃-၁ နေရာ-၁ (TV-1) ၌ယာဉ်သွားလာမှုနှုန်း စောင့်ကြည့်လေ့လာခြင်းအခြေအနေ
